# **Antimisting Fuel (AMK) Flight Degrader Development and Aircraft Fuel System Investigation**

George A. Coffinberry  
Thomas M. Tucker

General Electric Company  
Aircraft Engine Business Group  
Cincinnati, Ohio 45215

Final Report

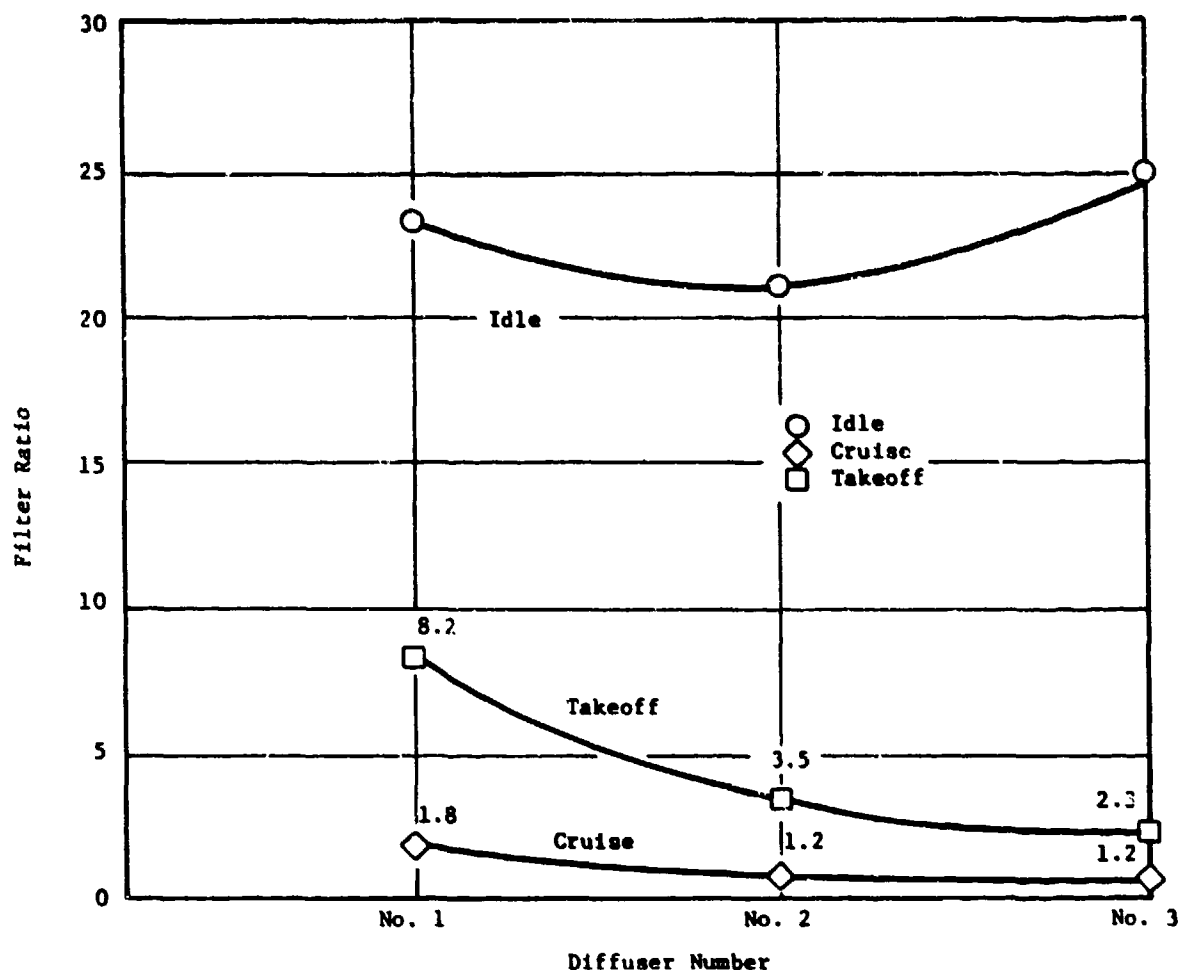
FIGURE 3. FILTER RATIO RESULTS FROM PROOF-OF-CONCEPT TESTS

The pump was tested with three diffuser configurations: standard (No. 1), close-clearance standard diffuser (No. 2), and increased recirculation (No. 3). Diffuser No. 3 was chosen as the baseline design for the degrader flight test program. Figure 3 summarizes the filter-ratio results of the different diffusers at three operating conditions. Further data analysis indicated no detrimental side effects from the diffuser modifications in terms of pumping performance or pressure stability.

At low idle flows, a threshold pump speed required for any significant AMK degradation was identified. Also, it was noticed that increasing fuel flow at a given pump speed reduced the level of degradation. Results achieved with the No. 3 refined diffuser were considerably better than the results with a standard diffuser. Although absolute input power levels were high, a significant improvement in degradation was achieved by a means other than a large increase in power input. For example, at a constant idle flow with the No. 3 refined diffuser, the filter ratio dropped from 23.2 to 1.3 by increasing pump speed from 16,634 to 18,000 rpm. That speed increase required a modest power increase of 6 horsepower. At takeoff flow (15,600 pph), 25 additional horsepower were required to reduce filter ratio results from 8.2 with the standard diffuser to 2.3 with the refined No. 3 diffuser. By using filter ratio for a qualitative comparison, it can be seen that impeller speed and diffuser design refinements yielded significant improvements at a relatively low increase in power requirement. Figure 4 compares the required input power of the three degrader configurations to the power requirements of the standard CF6-80A fuel pump with the higher fuel flow.

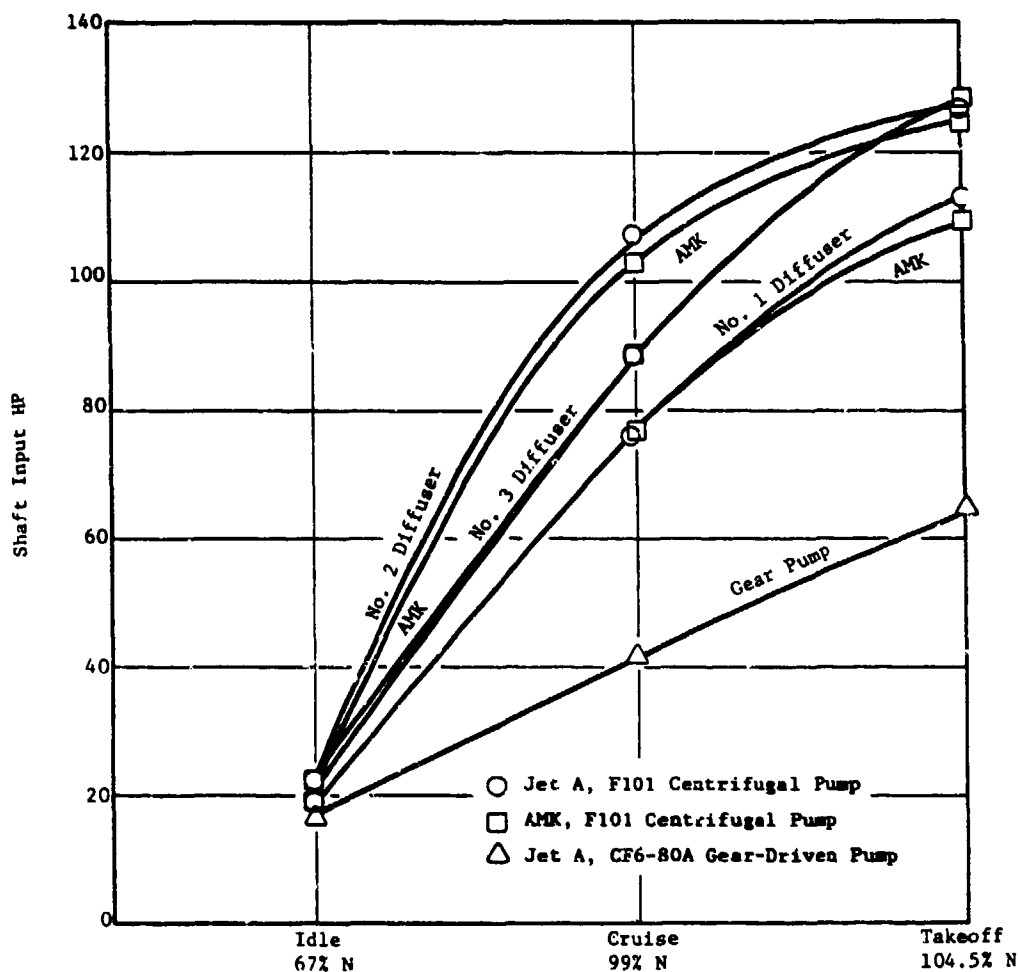
FIGURE 4. DEGRADER/PUMP POWER REQUIREMENTS

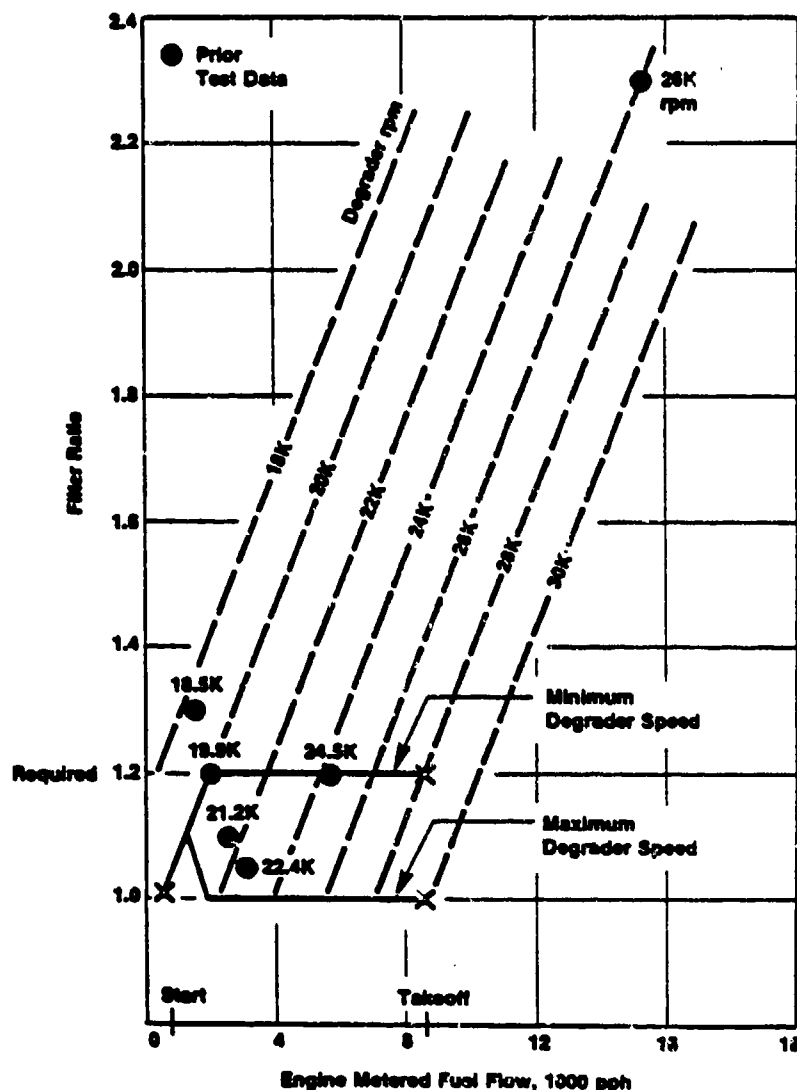
FIGURE 5. DEGRADER SPEED SCHEDULE RELATIONSHIP TO FLOW AND FILTER RATIO

The test results were then used to construct a plot of filter ratio as a function of CV880 engine fuel flow and degrader speed (Figure 5). Initial test results also showed that a minimum, or threshold, speed for degrading with the F101 impeller was 18,500 rpm. Filter ratio increased to 23 below this speed. Based on the speed parameter alone, the test results generally appeared consistent. For filter ratios near 1.0 (Jet A), the degrader/pump speed envelope for the CV880 was defined from initiation of engine start (600 pph at 12% N<sub>2</sub>) to takeoff (8,600 pph at 103% N<sub>2</sub>). A degrader speed of 20,000 rpm was selected as the necessary minimum at idle conditions. For the CV880 takeoff flow (8,600 pph) 28,000 rpm was required as the upper limit for degrader speed. When the B720 takeoff flow of 10,500 pph was addressed later on in the program, 32,000 rpm was required to maintain filter ratio near 1.0.

Figure 5, shown earlier, contains a family of curves which relate the required speed of the pump/degrader, at a given flow, that is necessary to produce the required filter ratio of 1.2. To incorporate the degrader into an aircraft fuel system, the power input to the pump/degrader and the corresponding fuel temperature rise downstream of the degrader had to be addressed. There were two related areas of concern: (1) engine fuel inlet temperature and (2) engine oil-cooler fuel discharge temperature (see Figure 11).

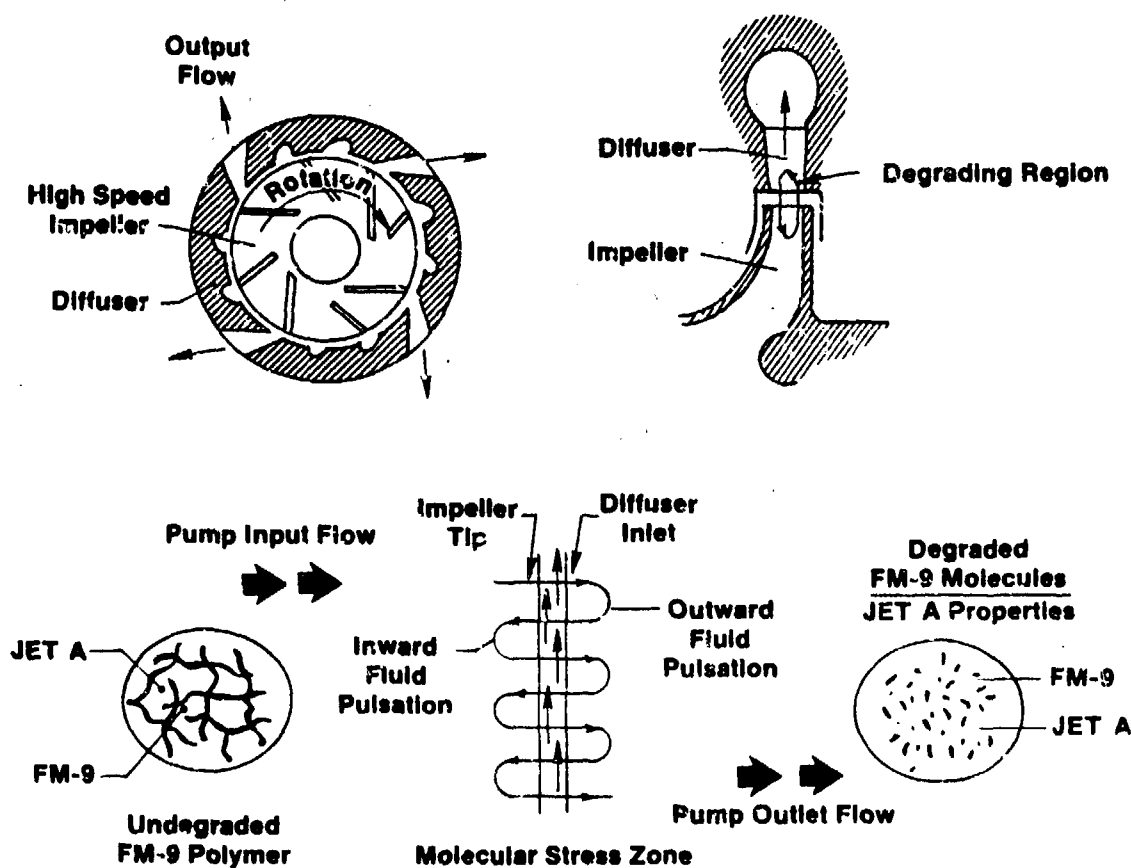
FIGURE 6. MODIFIED CENTRIFUGAL PUMP DEGRADING MECHANISMS

There are many ways to degrade AMK fuel; potential methods range from simple food blenders to high-pressure-drop-orifice devices. All of these devices impart energy to the fluid in an attempt to fracture the long-chain FM-9 molecule and revert the characteristics of the AMK back to those of untreated Jet A. General Electric has taken the approach of using a pulsating field of high-velocity fluid shear in the region of the discharge of a high-speed, centrifugal pump. Figure 6 shows the the degrading region of a centrifugal pump where very rapidly alternating inward and outward fluid pulsation creates what is called a molecular stress zone. Selective changes to the diffuser-blade angle, along with scallops in the diffuser housing, were incorporated into the design of the General Electric degrader. These changes tended to increase pump recirculation and enhanced the degrading characteristics of the pump.

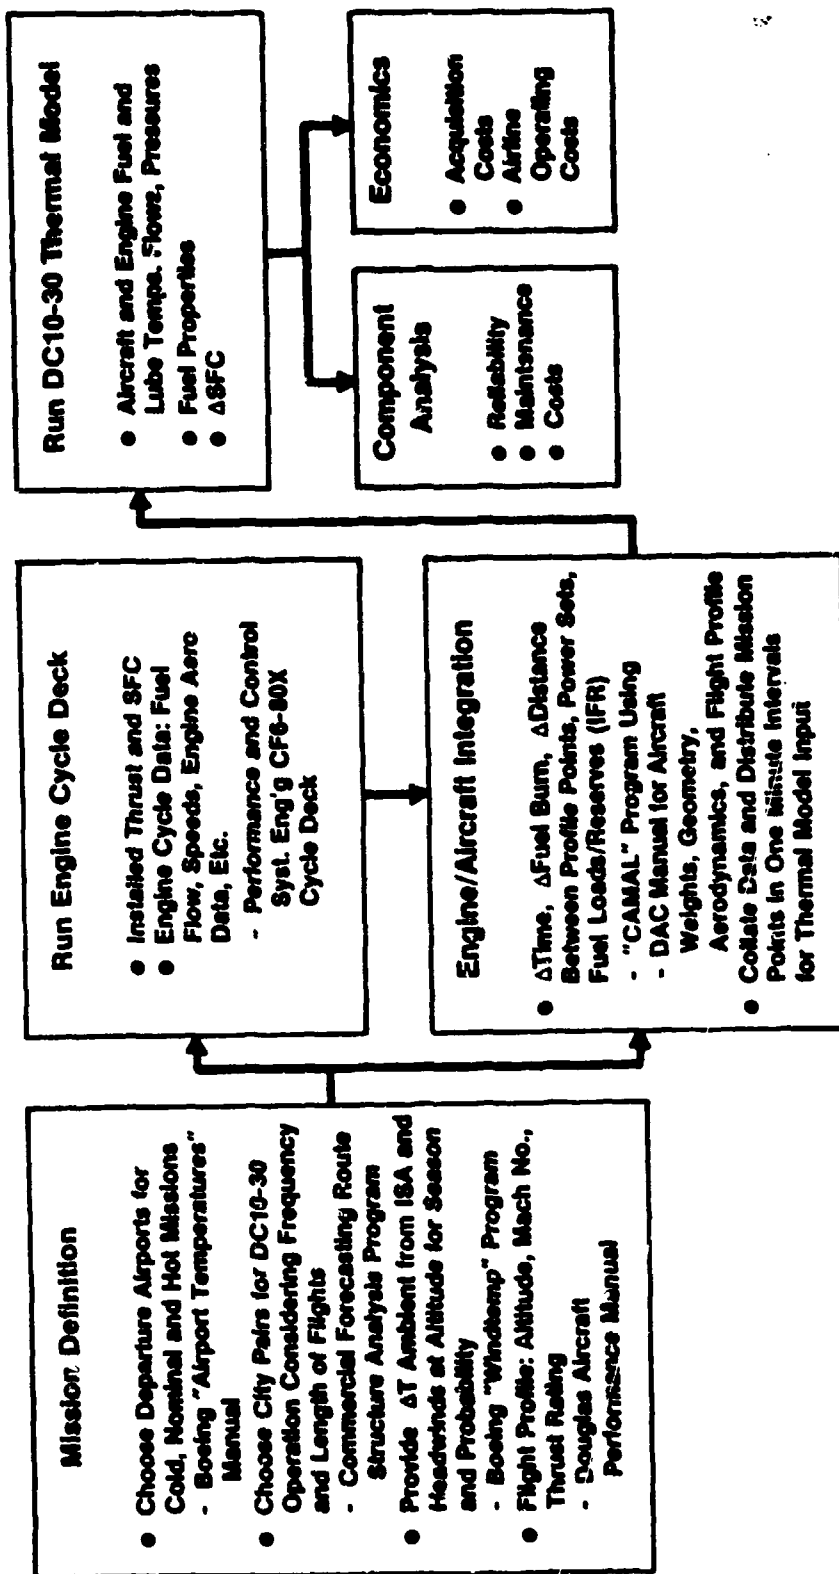
FIGURE 7. DC10/CF6-80 COMPUTER MODEL FLOWCHART

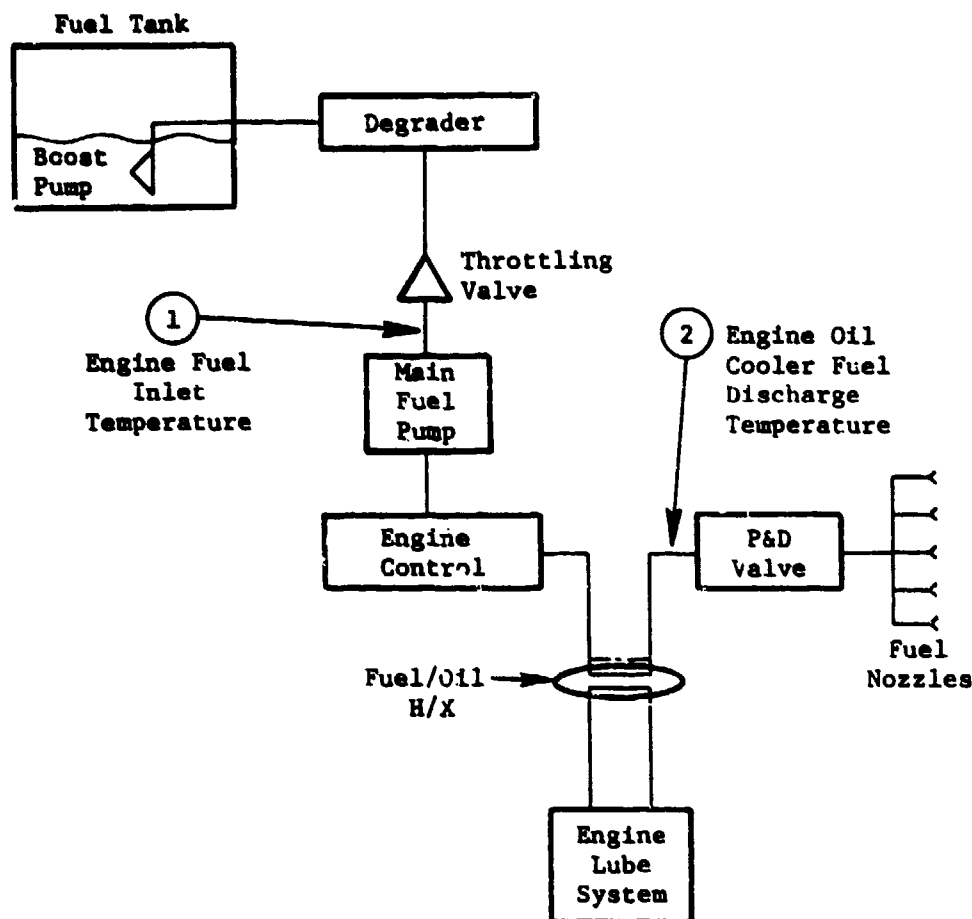
FIGURE 11. SIMPLIFIED DEGRADER INSTALLATION SCHEMATIC

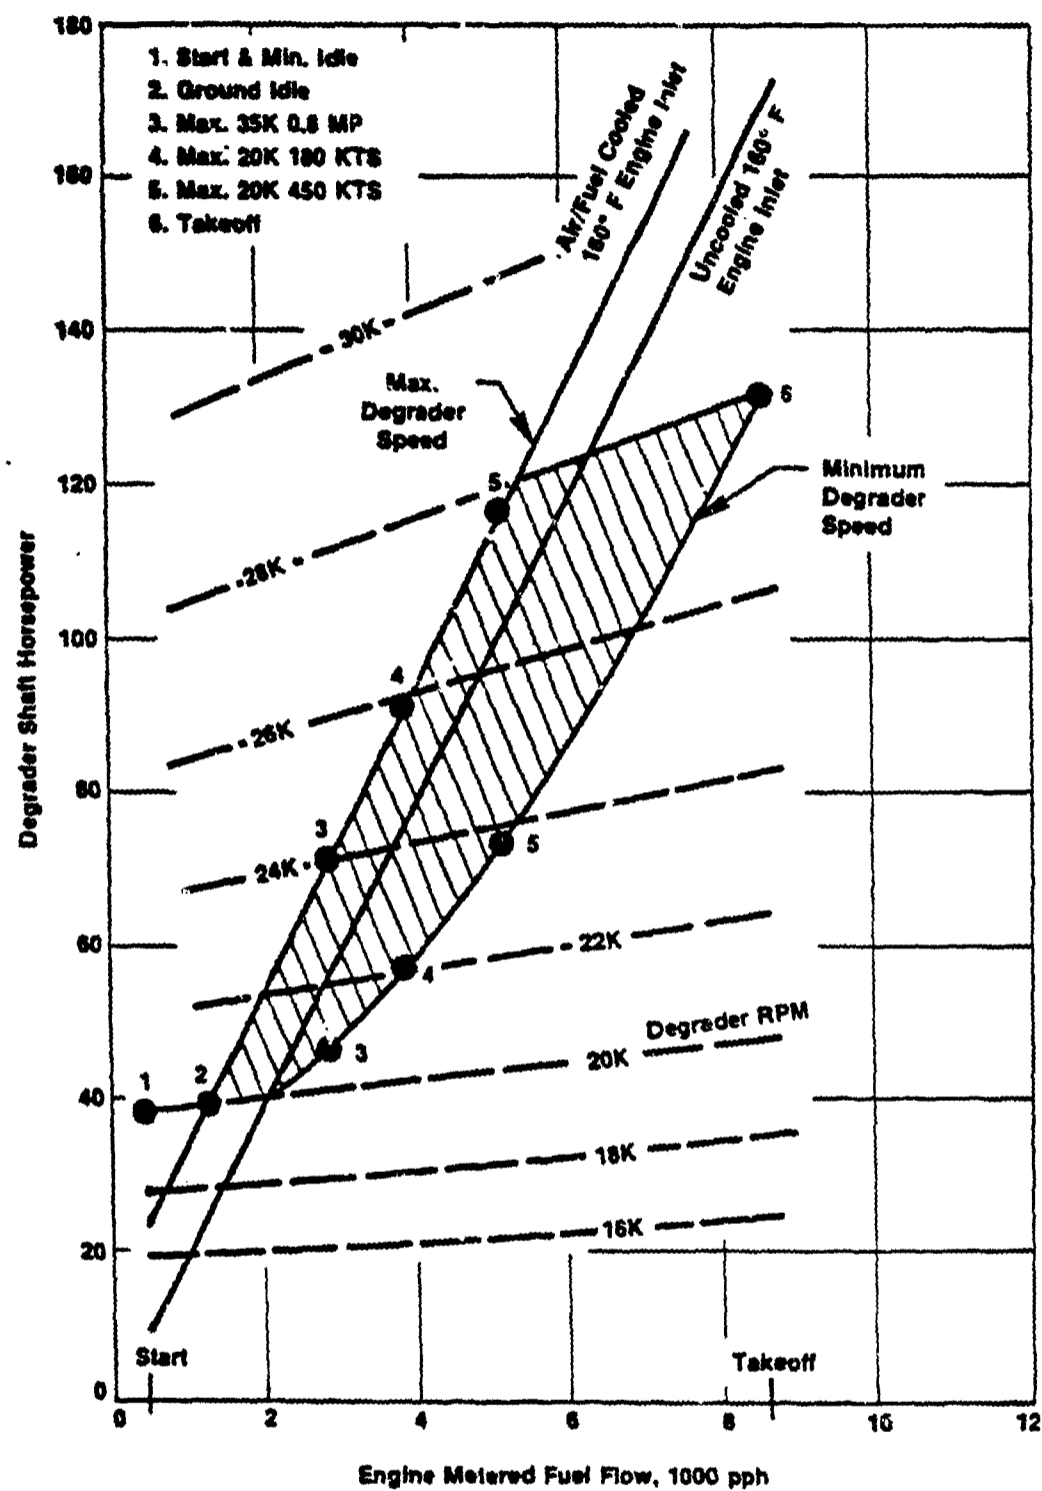
FIGURE 12. CJ805 DEGRADER SPEED SCHEDULE RELATIONSHIP TO FLOW AND POWER

As shown in Figure 12, with the addition of the fuel-to-air heat exchanger, the degrader could operate between the limits of the upper curve (air-cooled fuel) and the lower curve which was set by a required filter ratio of 1.2. Figure 14 shows the fuel-temperature margin that existed in the CJ805 engine with the additional fuel-to-air cooler installed.

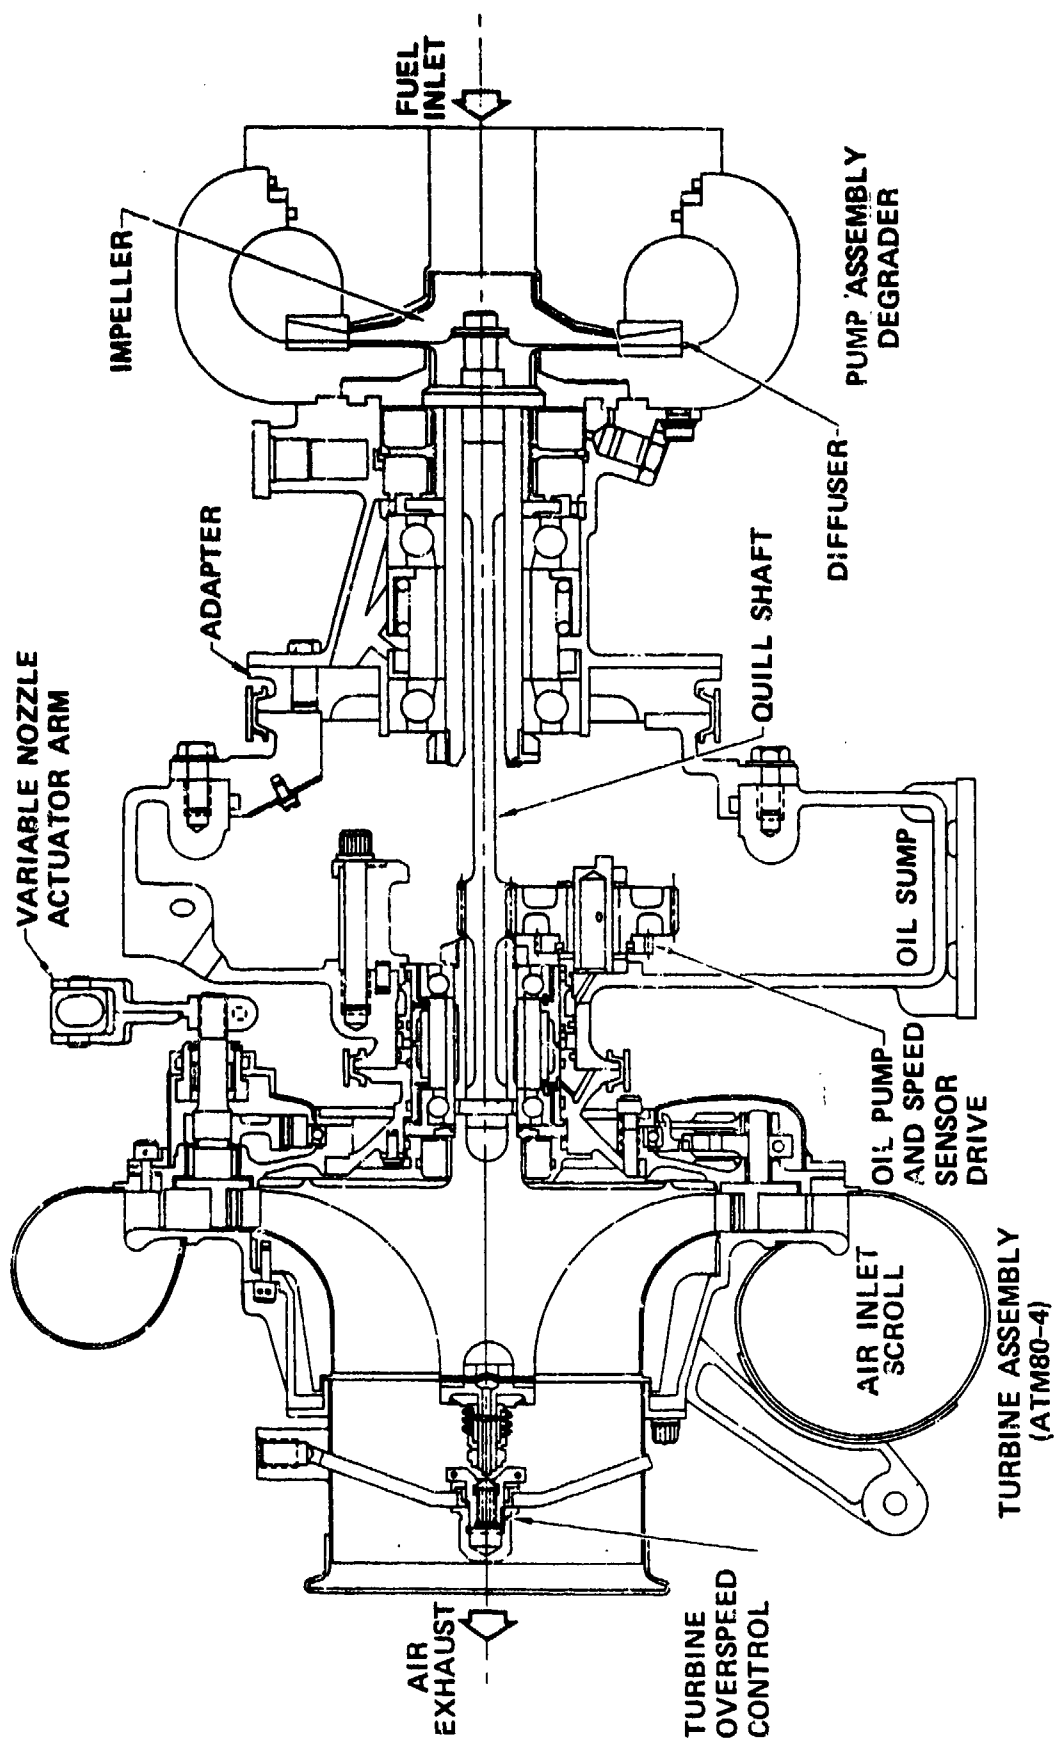
FIGURE 15. CROSS SECTION OF DEGRADER ASSEMBLY ATMP80-1

The inlet scroll received bleed air at a regulated pressure from the inlet valve. The scroll was designed to allow an equal pressure distribution at the inlet to the variable-area nozzles. The scroll was a brazed and welded 347 stainless steel sheet-metal-and-casting fabrication. The inner shroud of the

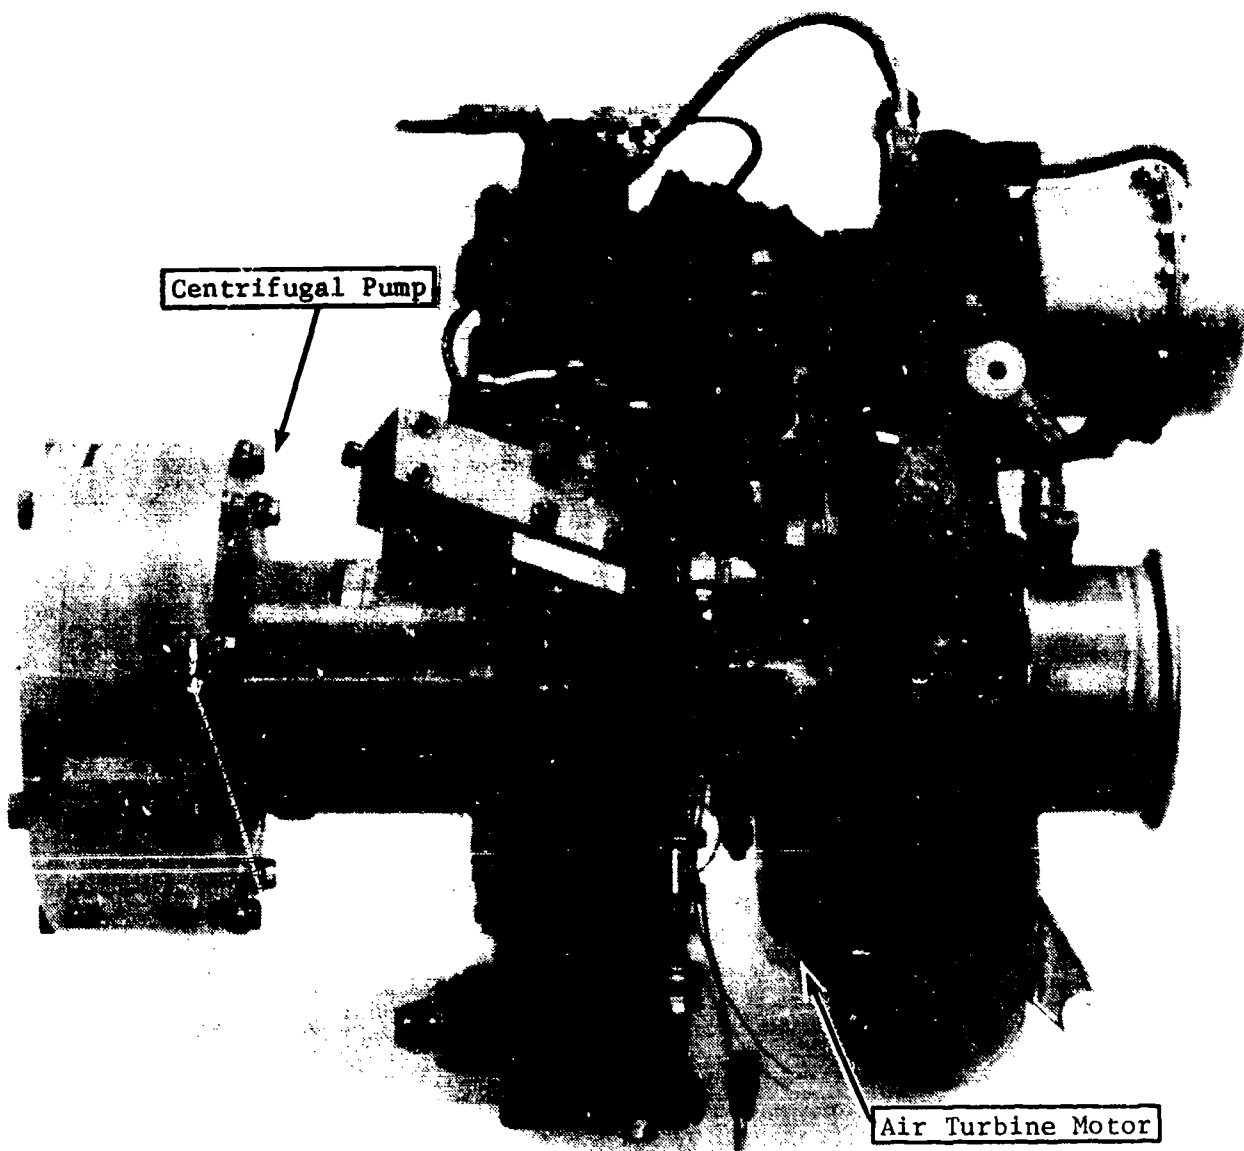
FIGURE 16. ATMP80-1 PUMP/DEGRADER ASSEMBLY

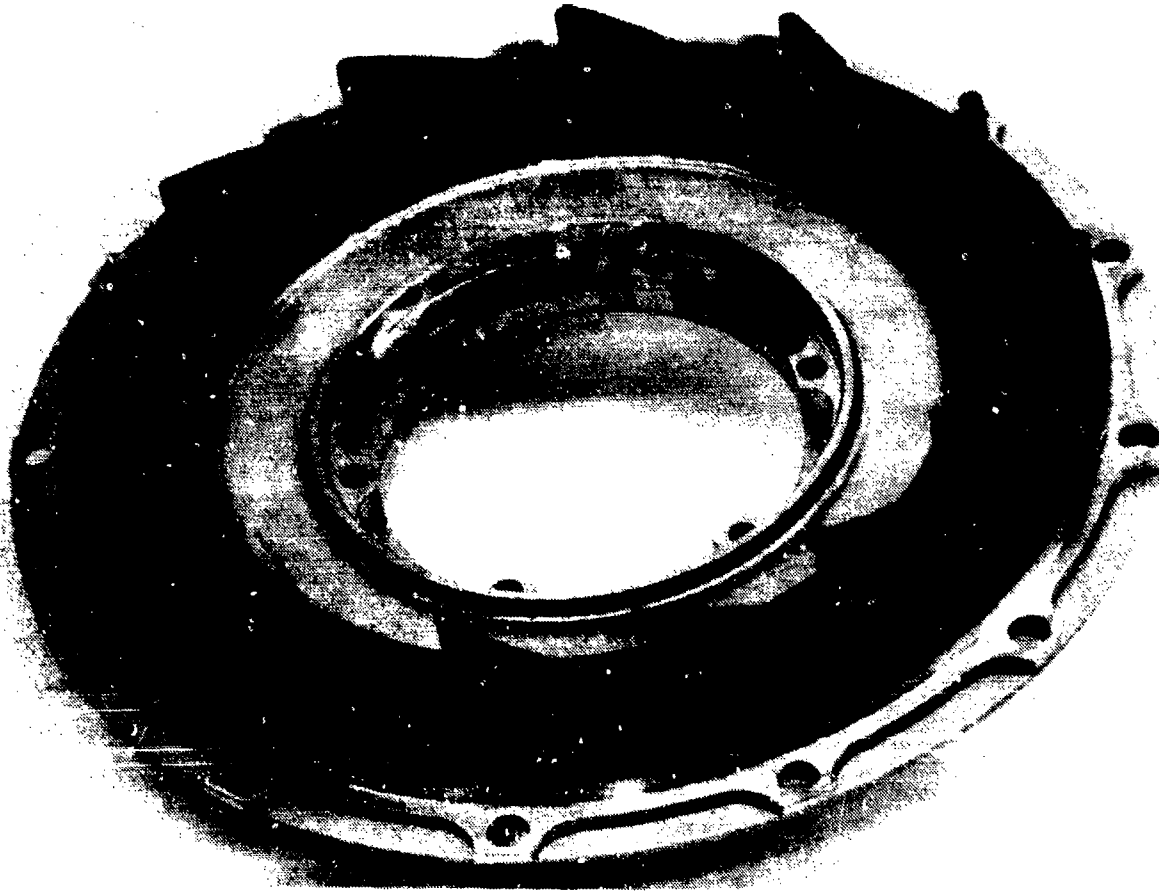
FIGURE 17. VARIABLE-AREA NOZZLE

range of operating conditions. The 17-4 PH CRES nozzle vanes were supported on sleeve bearings and designed to be aerodynamically loaded to close. Therefore, in the event of failure of the servoactuator or linkage between nozzle vanes and servoactuator, the nozzles would close, and the air-turbine motor would shut down.

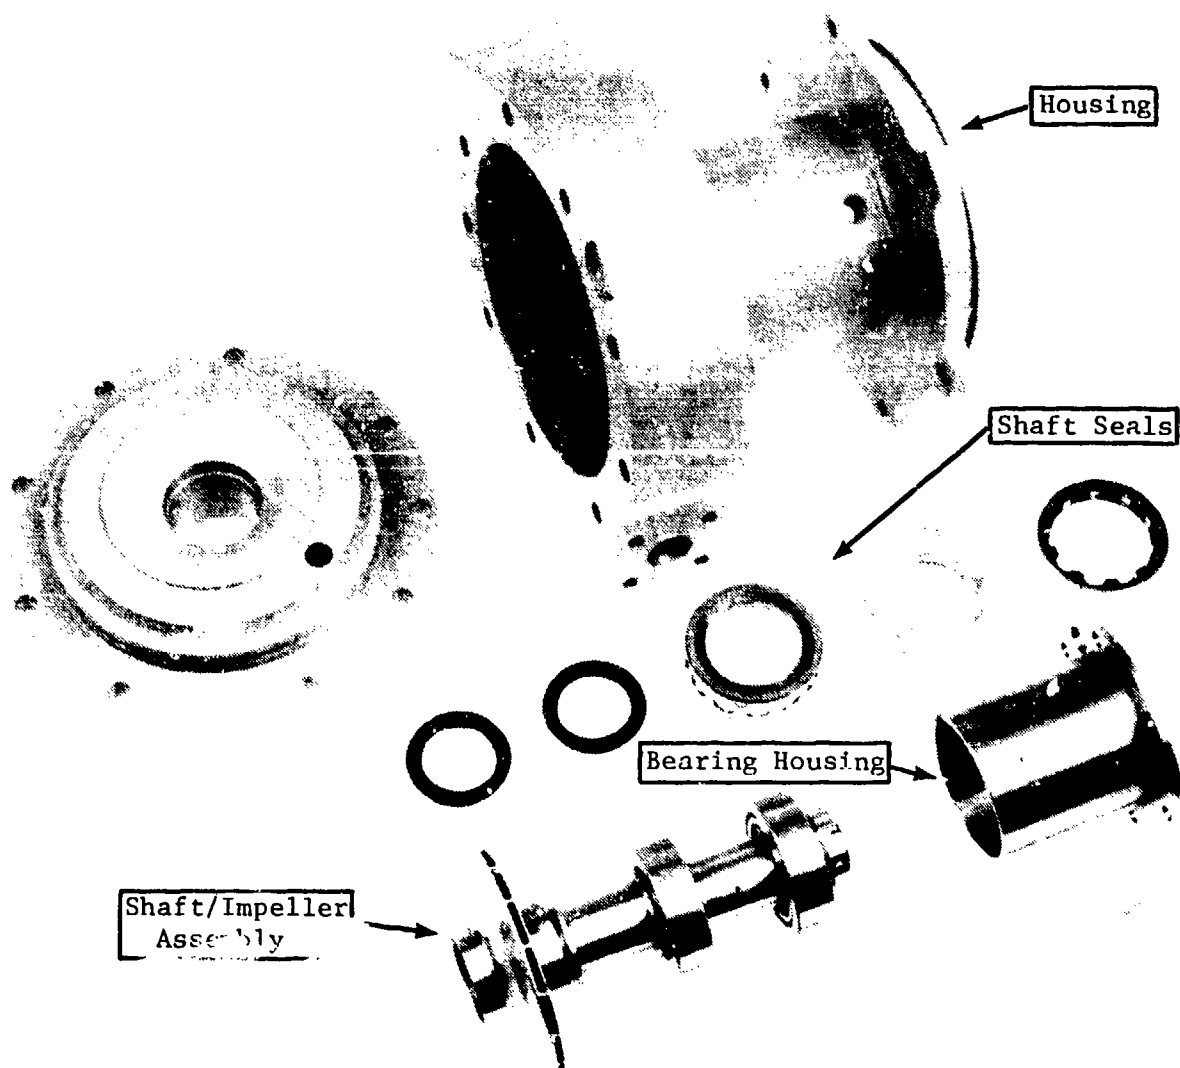
FIGURE 1 CENTRIFUGAL PUMP/DEGRADER COMPONENTS

Centrifugal Pump/Degrader. The pump/degrader subassembly included the impeller, diffuser, housings, shafts, seals, bearings, oil lubrication system, and mounting points (Figure 18). Oil at 45 psid provided bearing and spline lubrication. Oil drained from the drive end of the pump assembly into the oil sump. The quill shaft from the turbine drive interfaced with the ID spline in the pump shaft; both splines were oil-jet lubricated.

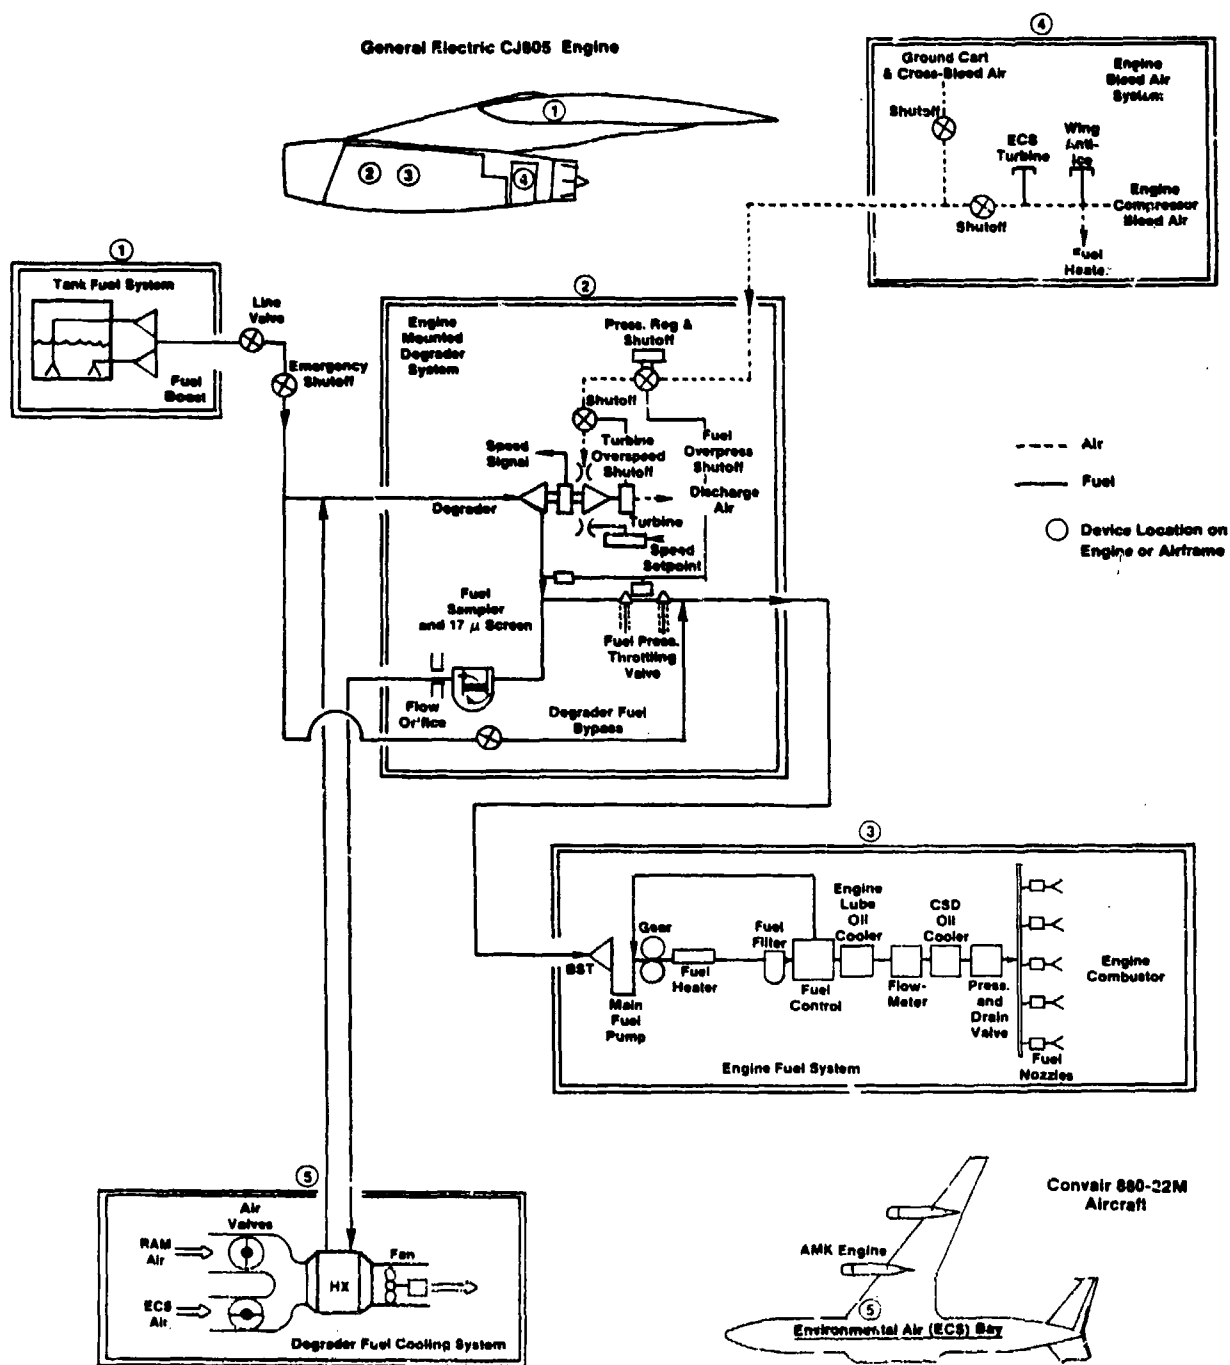
FIGURE 21. CONVERSIONS OF NUMBER 3 TANK AND ENGINE FOR AMK TESTS

AIRCRAFT INSTALLATION CONFIGURATION. Figure 21 illustrates the major degrader components, locations, and interfaces on the test aircraft. The No. 3 (right wing, inboard) engine and the No. 3 main fuel tank (right wing, inboard) were dedicated to AMK fuel operation during the program. Preliminary inspection

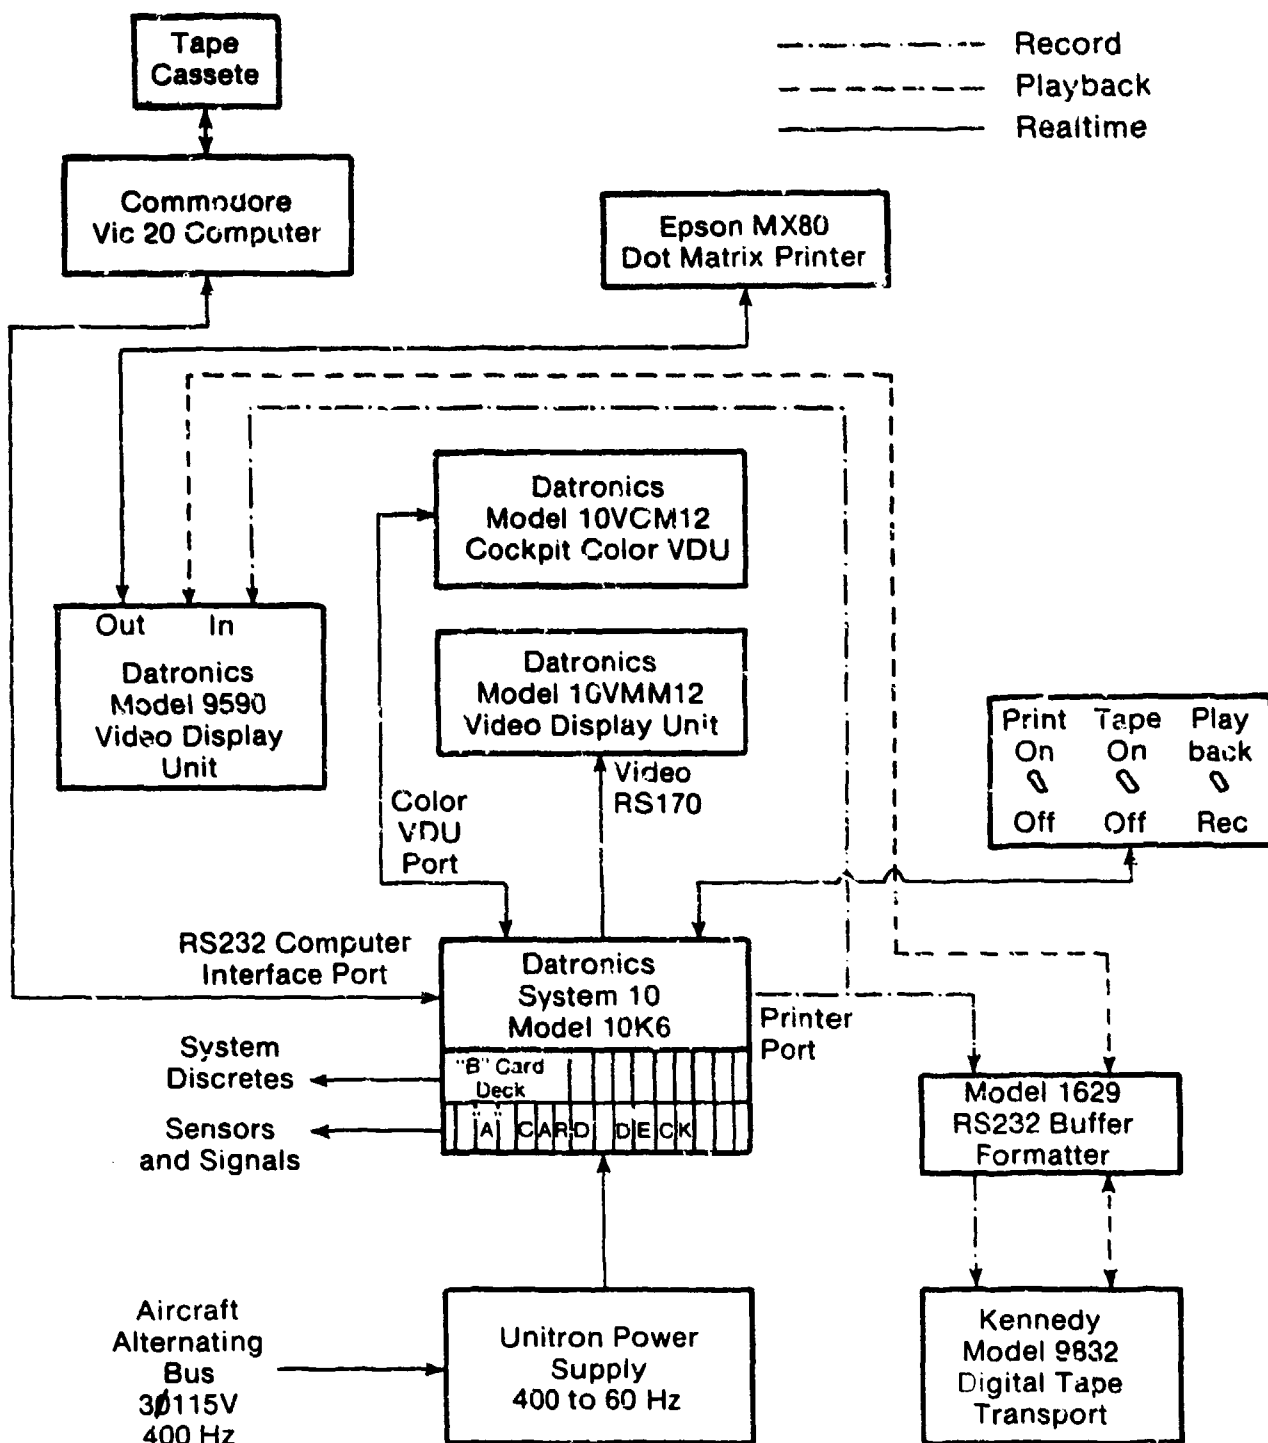
FIGURE 38. ONBOARD INSTRUMENTATION DATA SYSTEM SCHEMATIC

Critical test data displayed on the monitors in the cabin and cockpit were also transferred onto video tape. This feature proved to be very useful for a number of reasons. Backup was provided in the event the master Kennedy tape was lost, damaged, or could not be read by the GE-Evendale Honeywell 6000

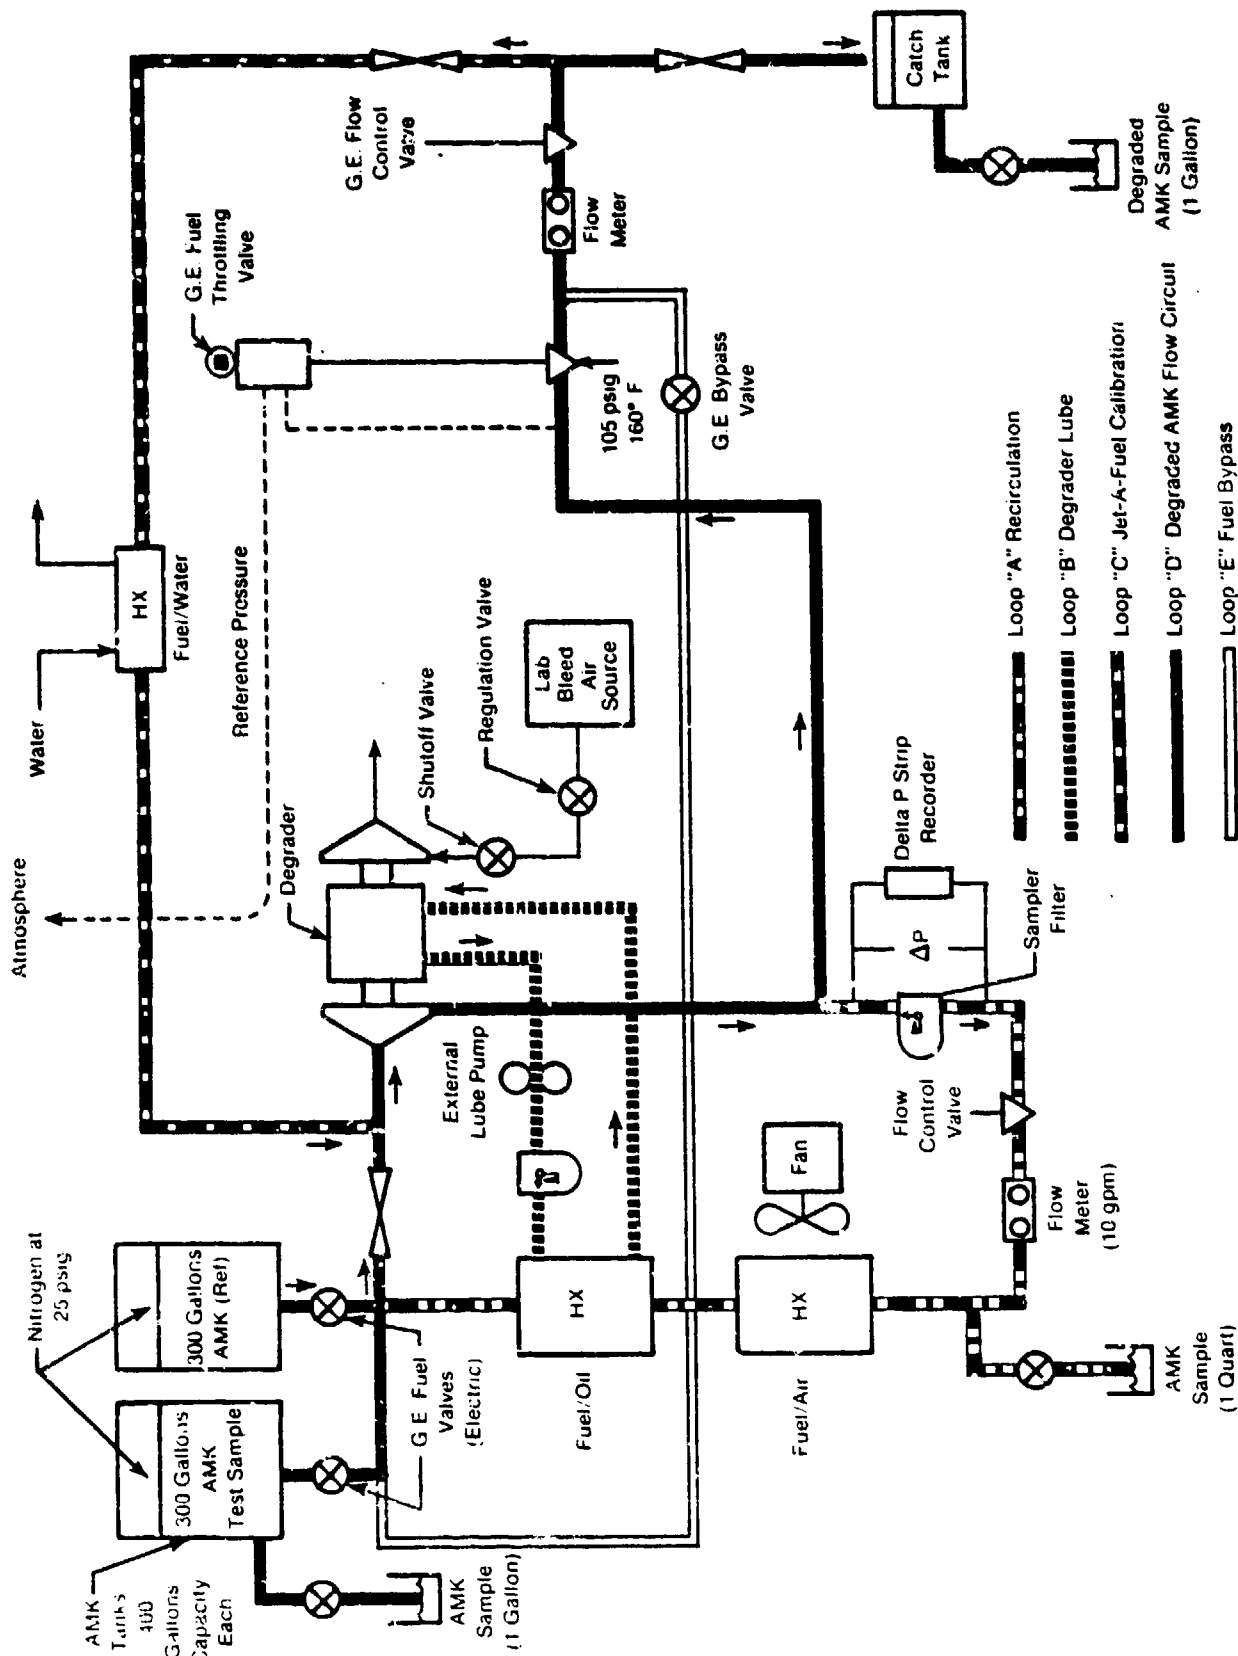
FIGURE 42. AMK FUEL DEGRADER SYSTEM TEST SCHEMATIC

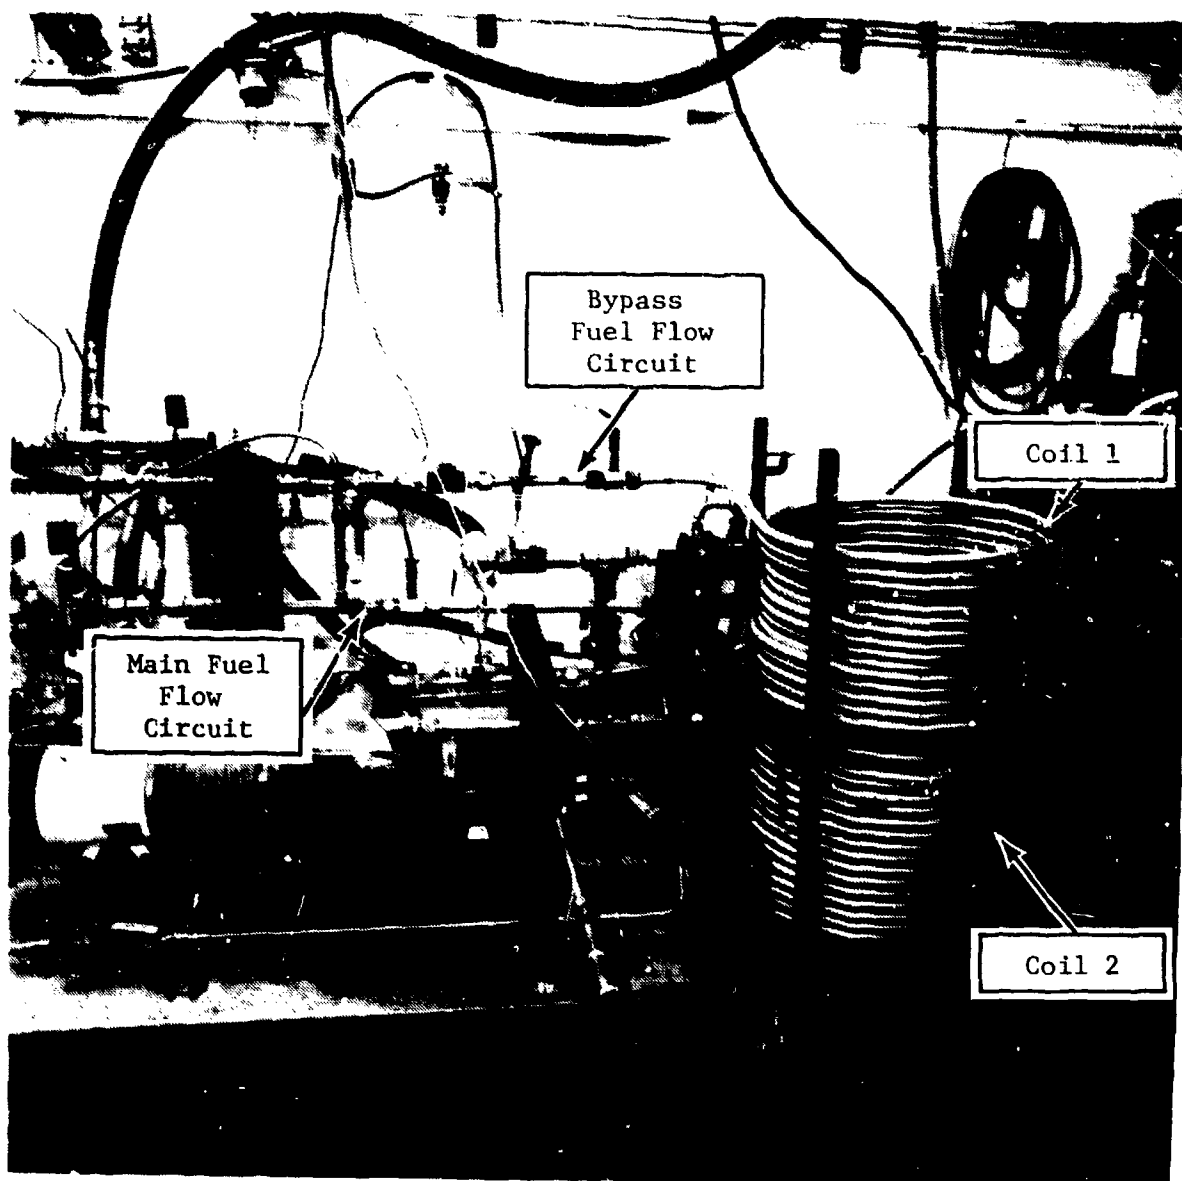
FIGURE 45. FUEL FLOW CIRCUITS

Figure 45 shows the coils incorporated in the tests to simulate the length of fuel line needed to reach from the No. 3 engine to the heat exchanger installed in the CV880 ECS bay. Figures 46, 47, and 48 are photos of the fuel cooling heat-exchanger assembly and the lubrication-system components.
